# Sonnax Has the

## Fix these common problems wherever they occur.

# 5L40-E Covered!

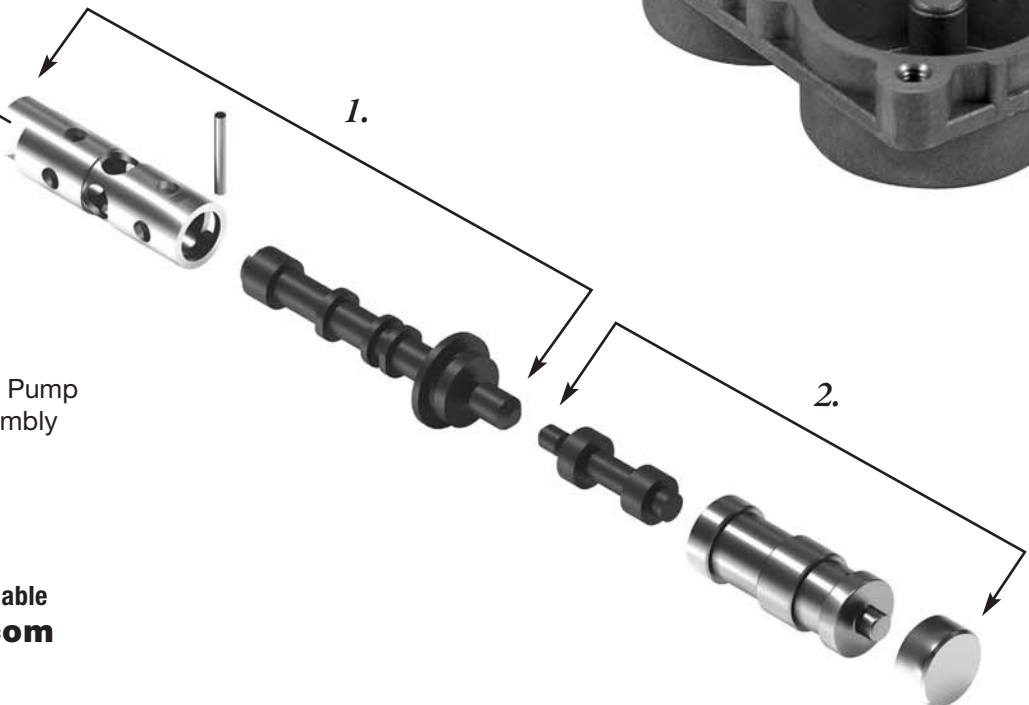
Fluid Pump Assembly

#### Pressure Regulator Valve & Sleeve Kit

##### *Helps cure:*

- Worn Pressure Regulator valve bore
- Low pressure
- Gear ratio codes

**Note:** Requires tool kit 5L40E.VA07

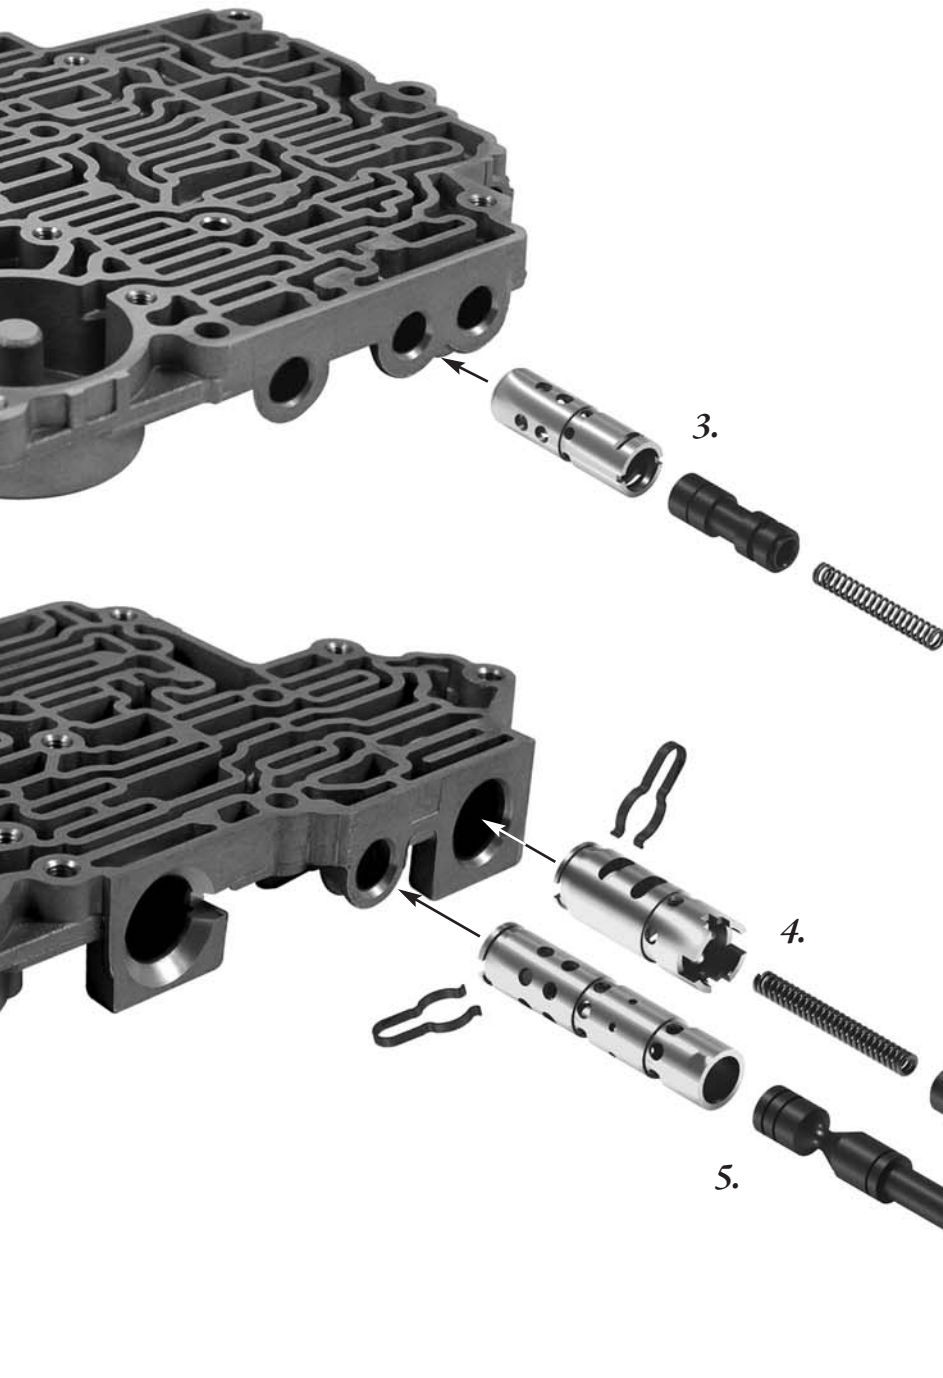
### Reverse Lockout Kit

#### *Helps cure:*

- Loss of reverse
- TCC overheat
- Burned reverse clutch

**Note:** Requires tool kit 5L40E.VA05 & the AG4.VA05 reaming fixture.
