# 5R55W/S Out of control?

**Six Sonnax kits allow you to repair the most common areas of valve body wear and restore pressure control.**

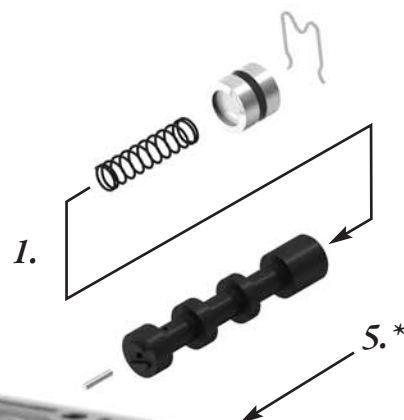
## 1. 56947J-05K

### Oversized TCC Control Valve Kit

#### Helps cure:

- Excess TCC slip, Code 741
- TCC lining comes off
- Overheated converters

**Note:** Requires tool kit F-56947J-TL2 & the VB-FIX reaming fixture

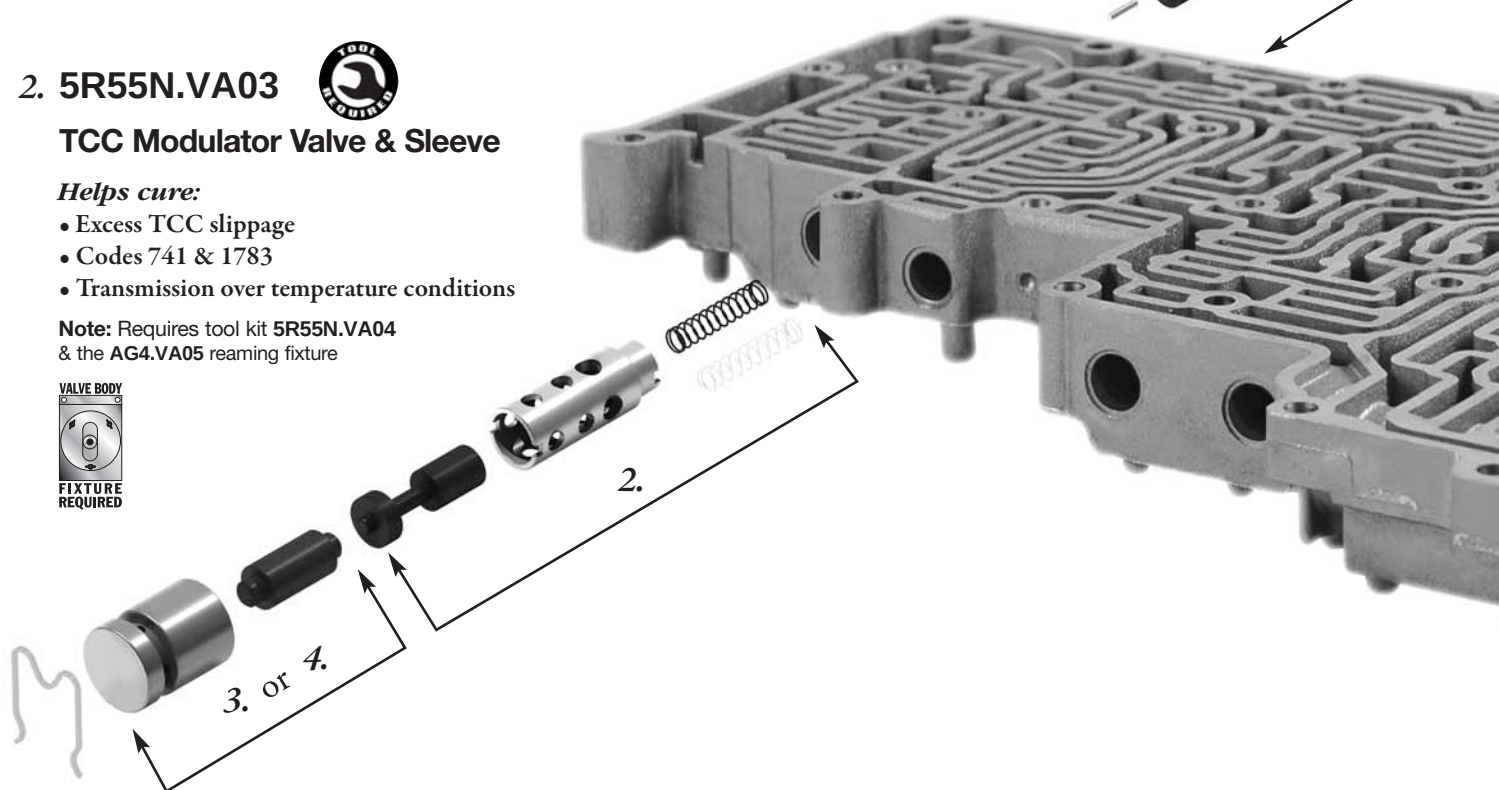
## 2. 5R55N.VA03

### TCC Modulator Valve & Sleeve

#### Helps cure:

- Excess TCC slippage
- Codes 741 & 1783
- Transmission over temperature conditions

**Note:** Requires tool kit 5R55N.VA04 & the AG4.VA05 reaming fixture
